# DETALLE ALCANTARILLADO SIMPLE

MUNICIPALIDAD DE MARÍA ANTONIA

OBRA: CONSTRUCCIÓN DE ALCANTARILLADO PLUVIAL	PLANTAS DETALLE	1:50
LONGITUD: VARIABLE	LAMINA 1	
UBICACION: CAMINO ACCESO A INST. EDUCATIVA

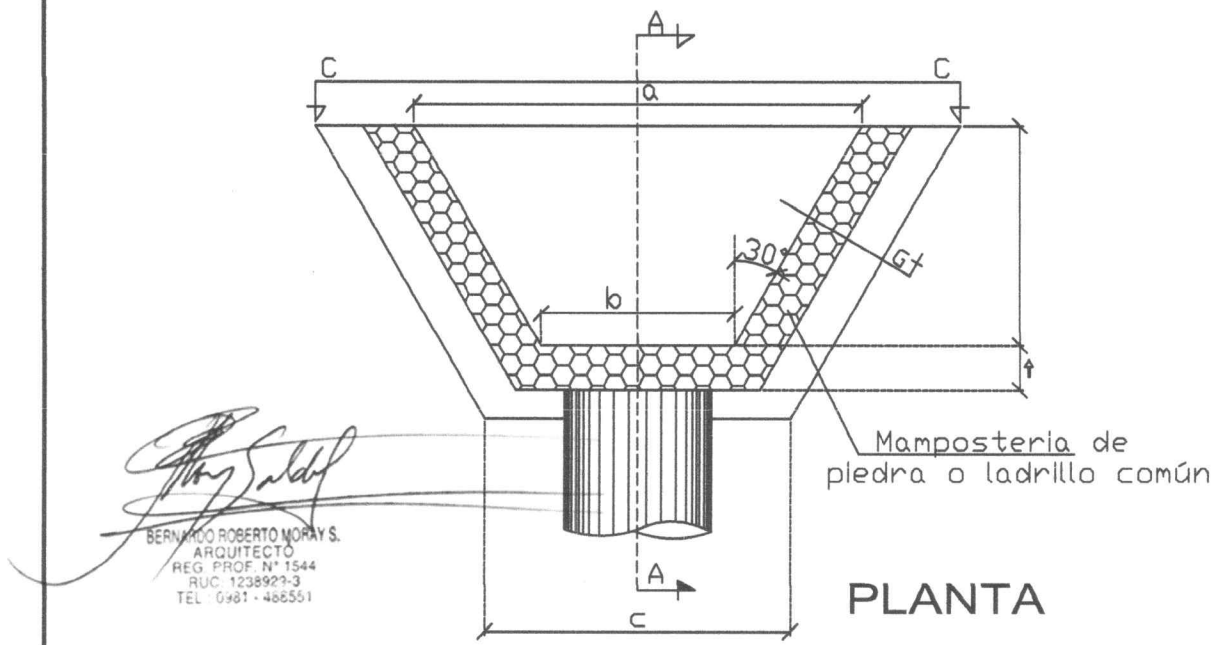
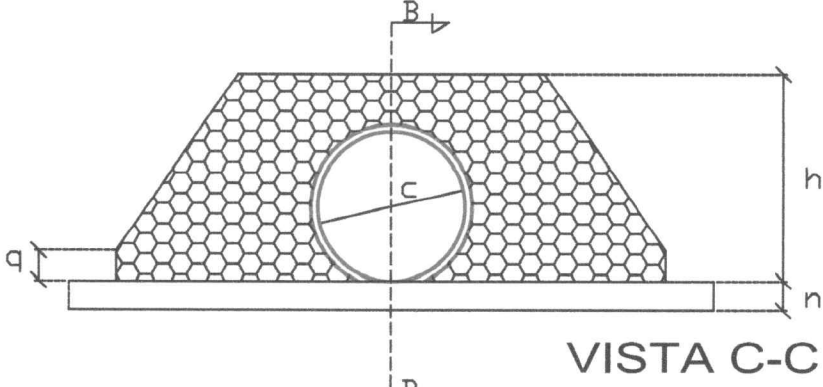
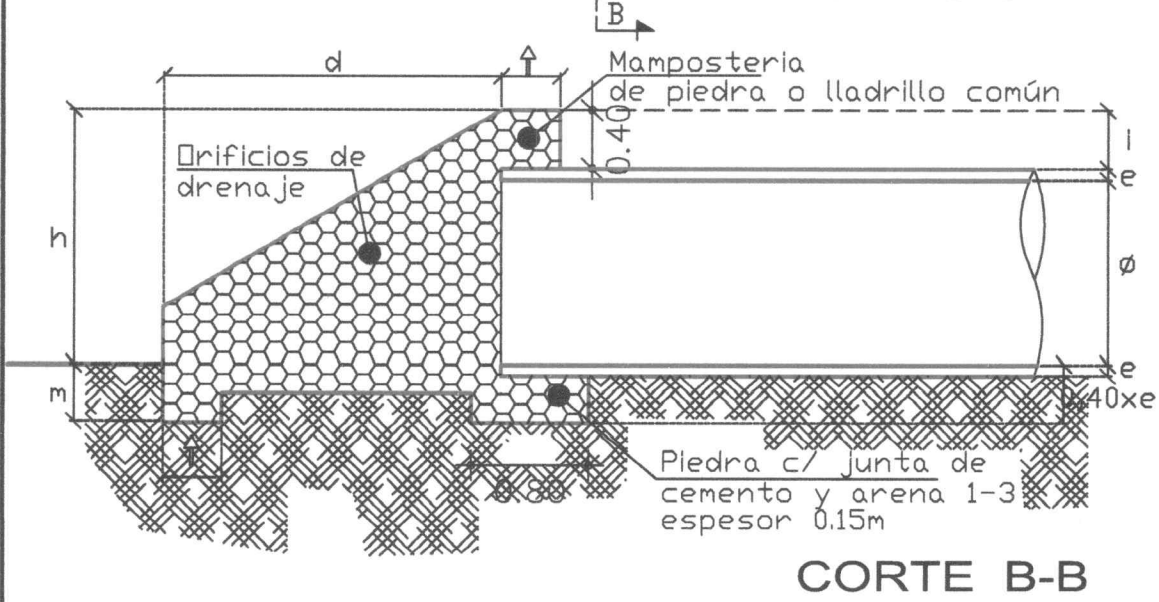
$\phi$	Ang	a	b	c	d	e	h	l	m	n	$\uparrow$	q
0.60	30-60	1.81	0.85	1.48	1.21	0.07	1.07	0.40	0.50	0.15	0.40	0.15
0.80	30-60	2.35	1.14	1.22	1.54	0.095	1.295	0.40	0.50	0.15	0.40	0.25
1.00	30-60	2.91	1.43	2.01	1.88	0.12	1.52	0.40	0.50	0.15	0.40	0.35
1.20	30-60	3.45	1.71	2.29	2.21	0.14	1.74	0.40	0.50	0.20	0.40	0.45

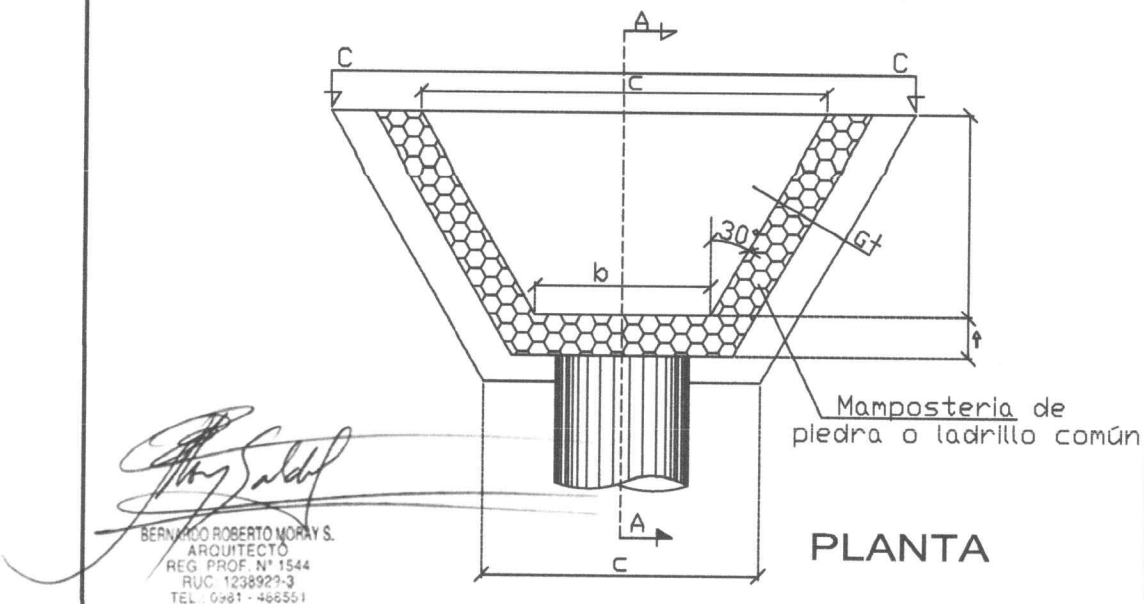
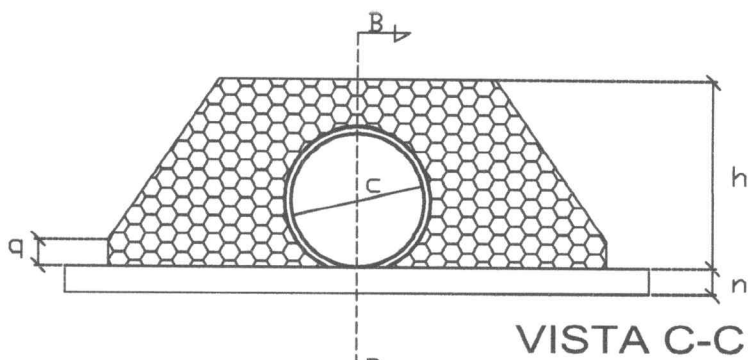
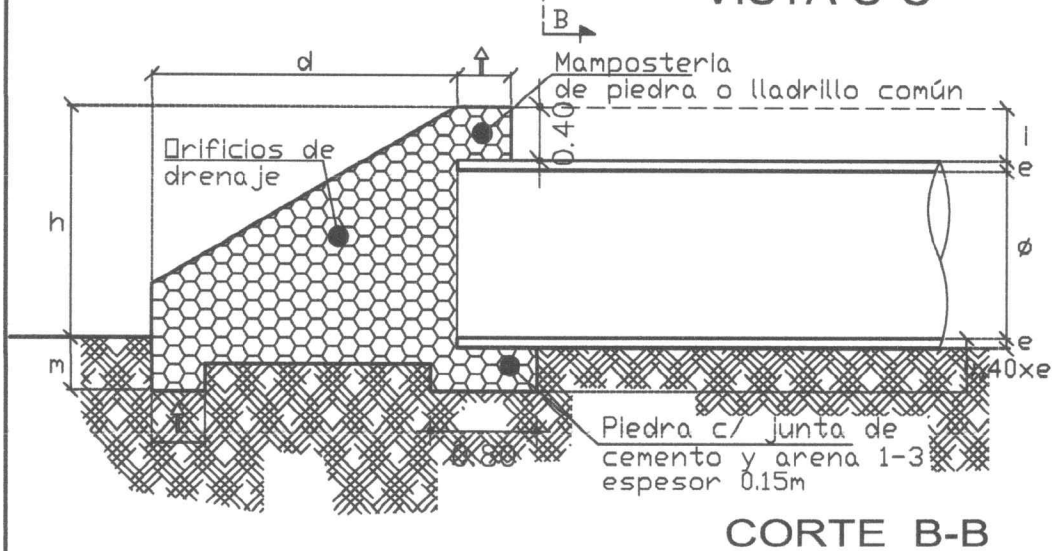
# DETALLE ALCANTARILLADO SIMPLE

$\phi$	Ang	a	b	c	d	e	h	l	m	n	$\uparrow$	q
0.60	30-60	1.81	0.85	1.48	1.21	0.07	1.07	0.40	0.50	0.15	0.40	0.15
0.80	30-60	2.35	1.14	1.22	1.54	0.095	1.295	0.40	0.50	0.15	0.40	0.25
1.00	30-60	2.91	1.43	2.01	1.88	0.12	1.52	0.40	0.50	0.15	0.40	0.35
1.20	30-60	3.45	1.71	2.29	2.21	0.14	1.74	0.40	0.50	0.20	0.40	0.45

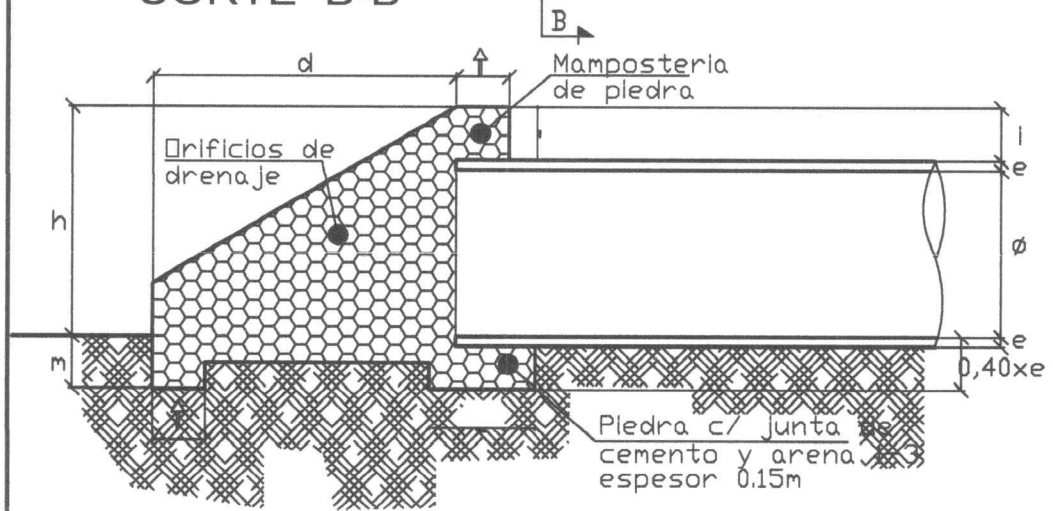
CORTE B-B

1Ch	Ang	a	b	c	d	e	h	l	m	n	↑	q
0.60	30	1.81	0.85	1.48	1.21	0.07	1.07	0.40	0.50	0.15	0.40	0.15
0.80	30	2.35	1.14	1.22	1.54	0.095	1.295	0.40	0.50	0.15	0.40	0.25
1.00	30	2.91	1.43	2.01	1.88	0.12	1.52	0.40	0.50	0.15	0.40	0.35
1.20	30	3.45	1.71	2.29	2.21	0.14	1.74	0.40	0.50	0.20	0.40	0.45
